Safety Inspection Report

Annual Inspection

Trooper Road

Aldbury Parish Council

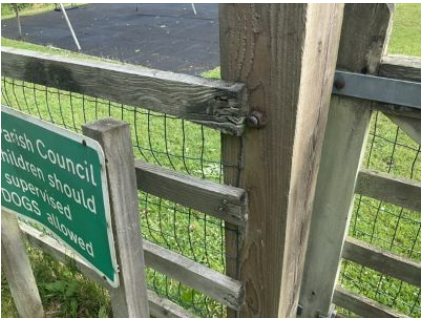
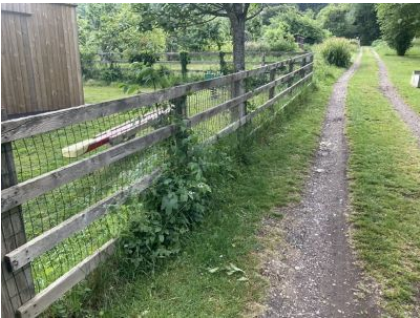
Description
Moderate repairs are needed.
Tasks
Read the notes for further action.
Note

Decay and loose in the ground. Repair/replace accordingly.
Monitor all timber items for decay throughout the year due to softening at ground level. Replace affected parts if found.

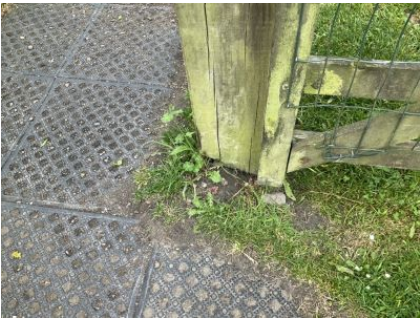
Description
Timber is decayed.
Tasks
Check on a routine basis., Replace affected parts.
Note
Gate slam post.

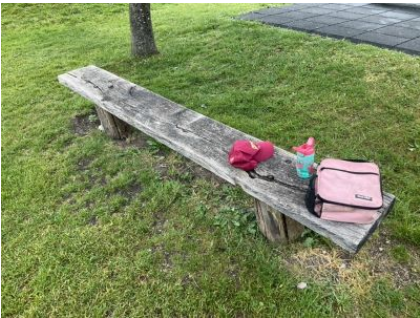
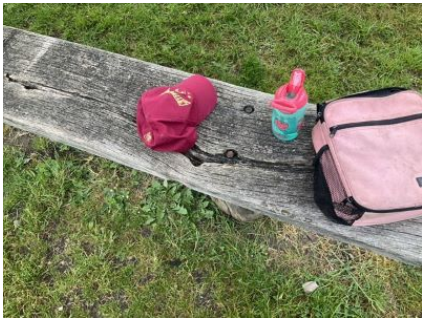
Timber is decayed.

Bench top and supports. Replace/remove entire bench.

Check on a routine basis., Replace affected parts.

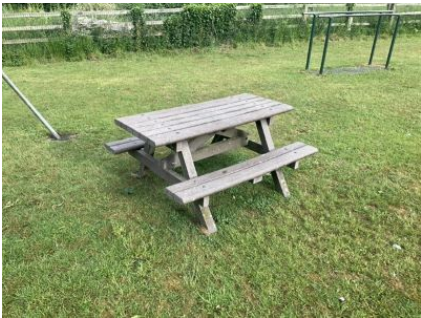
Portable equipment must remain outside the minimum space of the permanently installed items. Free movement of children within the play area may be affected. Without effective control the risks will increase. The risks associated with portable equipment will vary depending upon where the unit is placed.

Monitor and control the placement of portable items.

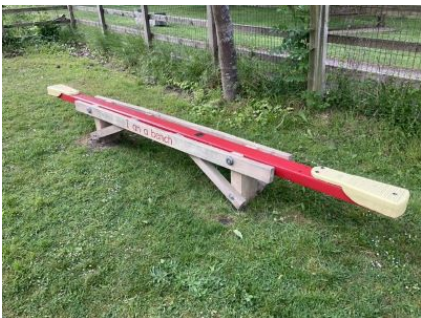
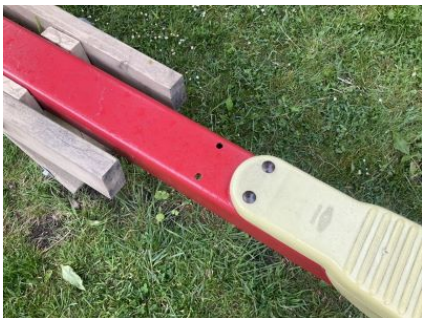
Recycled seesaw body used as seat has fixing holes creating entrapments. Consider filling.

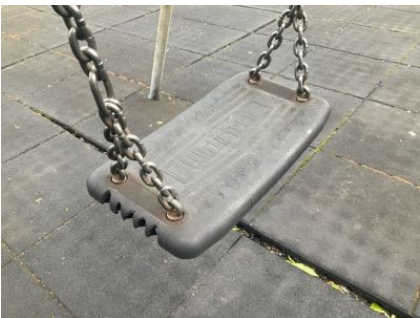
The swing seat has been damaged, but does not require immediate replacement.

Replace when metal is exposed.

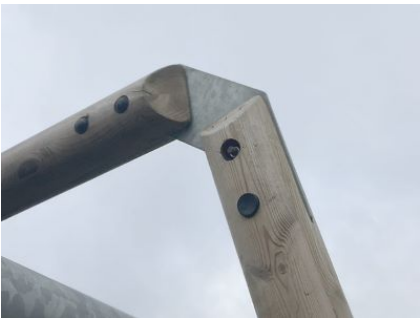
Cap missing.

Replace.

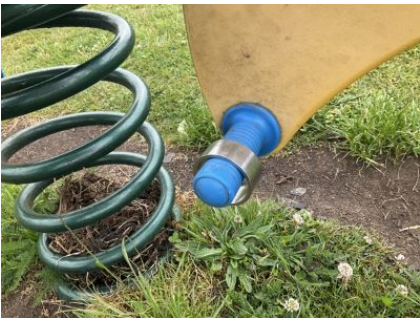
1. Bolt(s) loose.

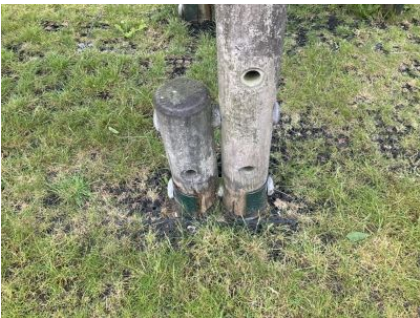
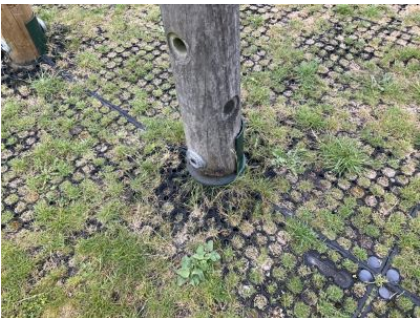
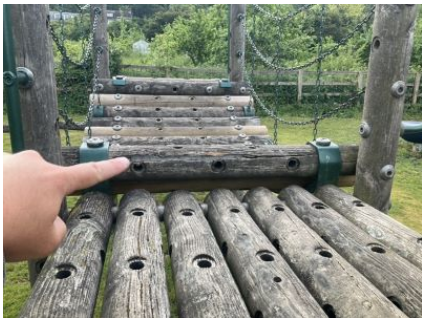
Timber is not in good condition.

Several logs on bridge and at ground level are not in good condition. Consider replacing all affected parts.

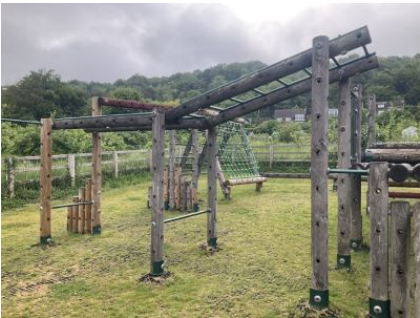
Overhead ladders and rings provide significant play value and benefits to children, and with it the risk of falling. Ensuring the surface remains in good condition will help to keep the correct balance between benefits and risk.

The protective surface under all bars and rings must be kept in good condition.

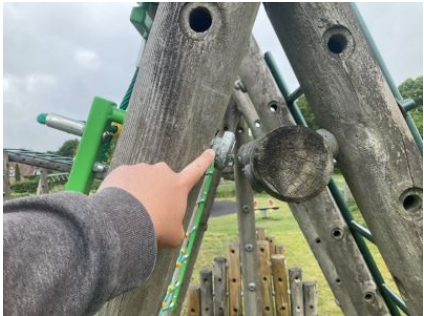
Fixtures loose or missing.

Several connectors on up and over. Log climbers. Post shoe bolts to supports. Overhead ladders and rung top bars/frames. Tighten all loose fixings.

Tighten/replace.

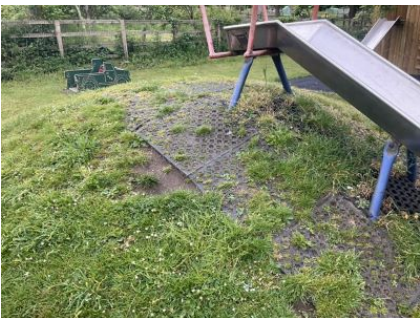
Surface needs repair.

Repair.

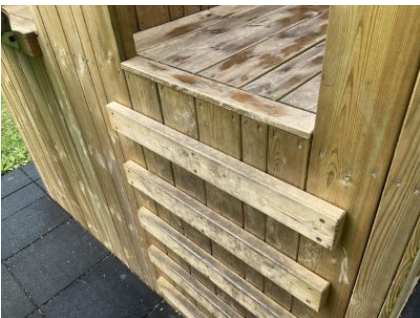
There is wear on the platform.

Repair.

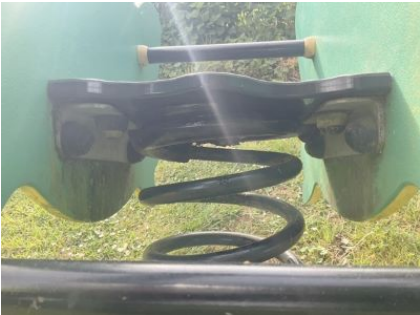
Bolt(s) loose.
