Safety Inspection Report

Annual Inspection

Trooper Road

Aldbury Parish Council

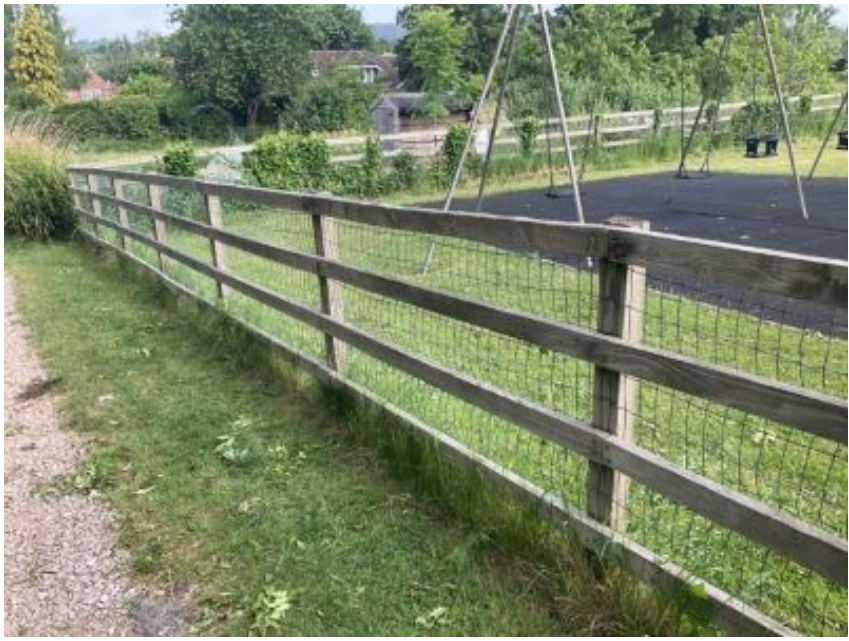
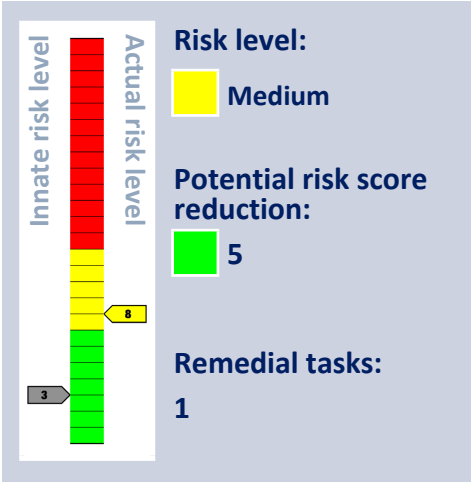
Fencing

Description
Moderate repairs are needed.
Tasks
Read the notes for further action.
Note

Decay and loose in the ground. Repair/replace accordingly.
Monitor all timber items for decay throughout the year due to softening at ground level. Replace affected parts if found.

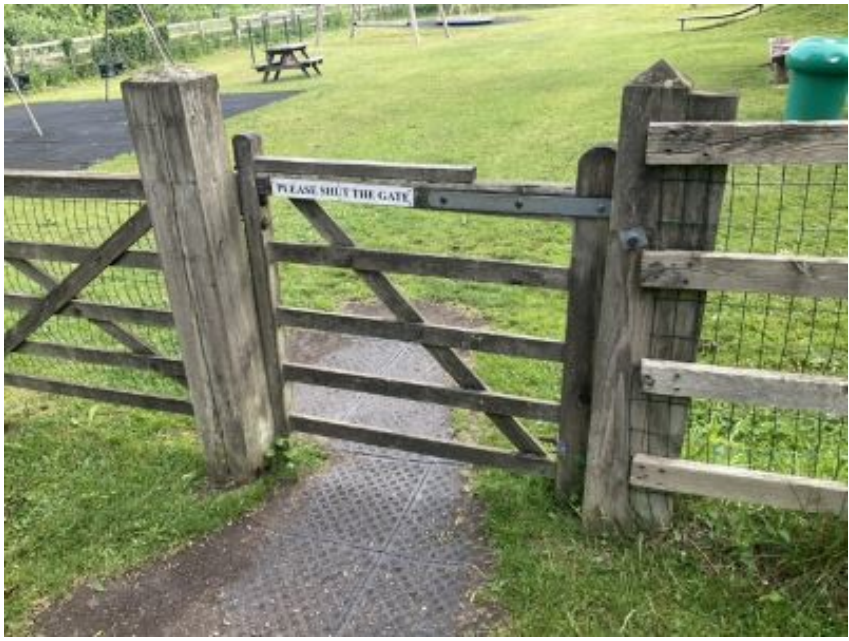
Description
Timber is decayed.
Tasks
Check on a routine basis., Replace affected parts.
Note
Gate slam post.

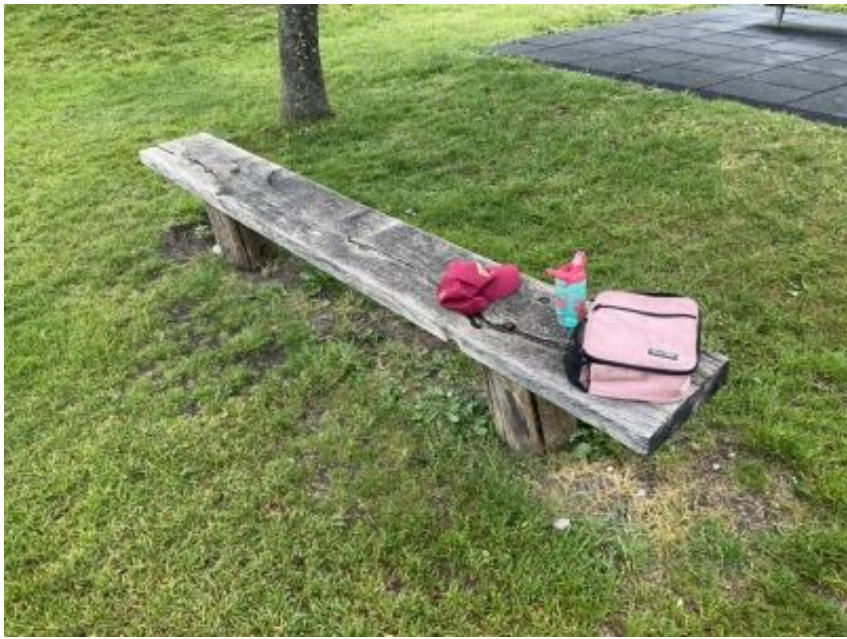
Seating - Various

Timber is decayed.

Bench top and supports. Replace/remove entire bench.

Check on a routine basis., Replace affected parts.

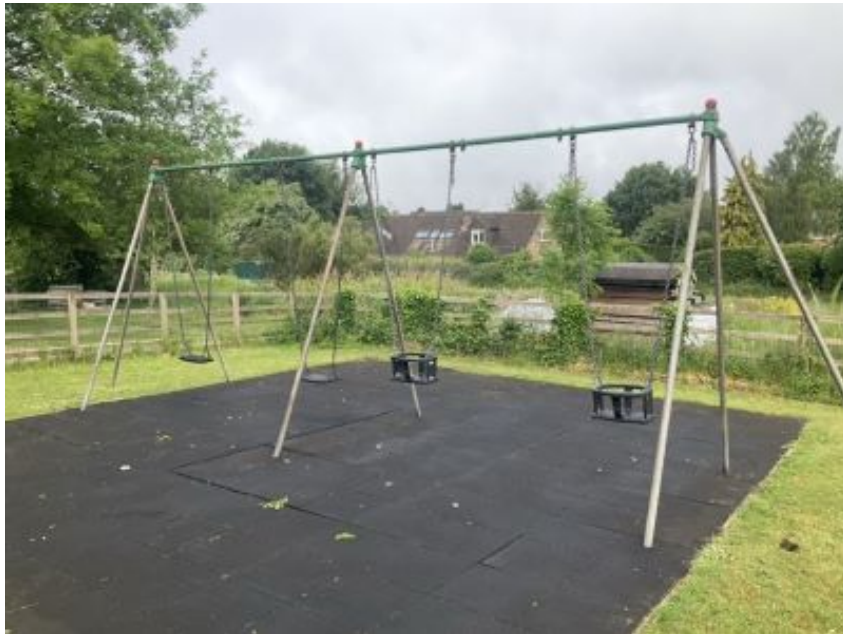
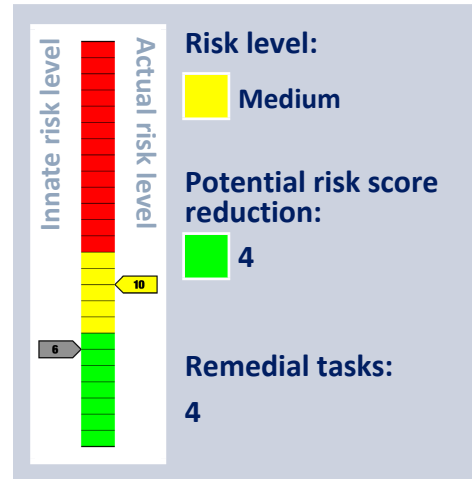
Swing - Mixed - 2 Bay 2 Junior 2 Toddler Seat

1. Gaps have opened up between tiles causing trip hazard.
2. The manufacturer of this equipment advises that due to its age it cannot guarantee its stability and that the item should be removed.
3. The swing seat has been damaged, but does not require immediate replacement.

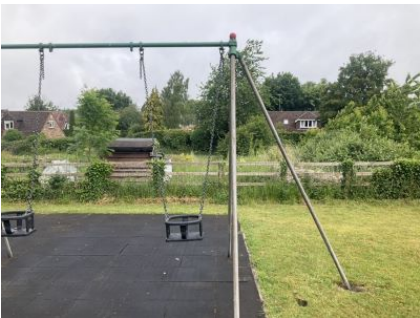
Gaps have opened up between tiles causing trip hazard.

Remove moss and grass from gaps and repair.
Replace damaged timber edging.

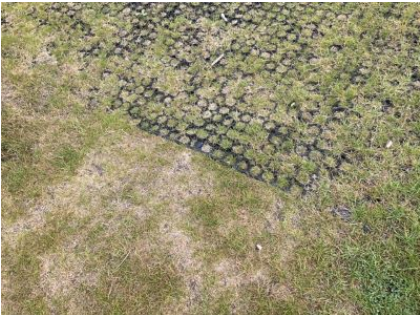
Surface needs repair.

Edges of matting have not been covered over, creating trip points around perimeters.

Repair.

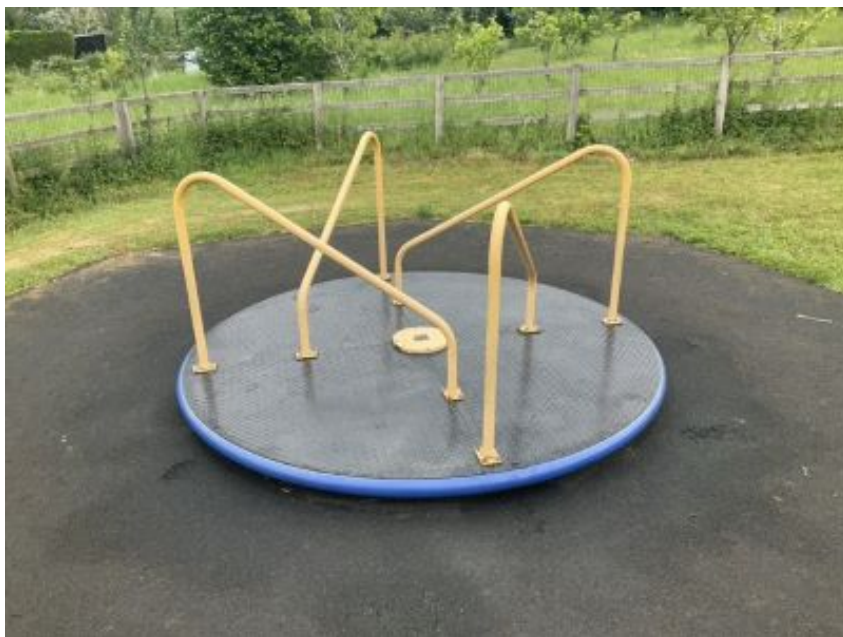
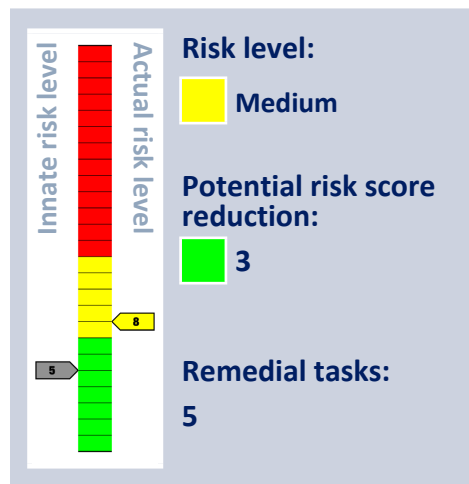
Carousel - Roundabout

1. Surface is wearing.
2. Trip points on the surface.
3. Bearings require service.

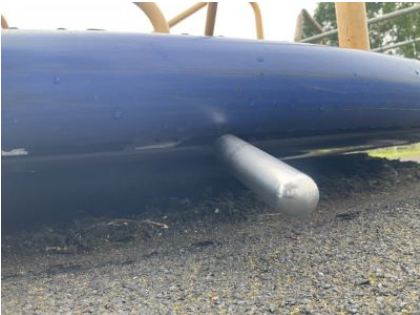
Surface is wearing.

Repair.

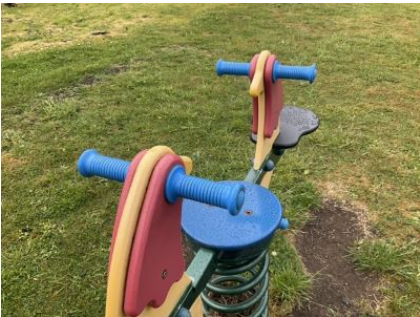
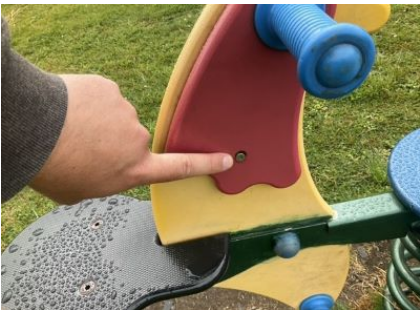
Bolt(s) loose.

Both sets of hand holds.
Body panel fixings are loose and projecting.

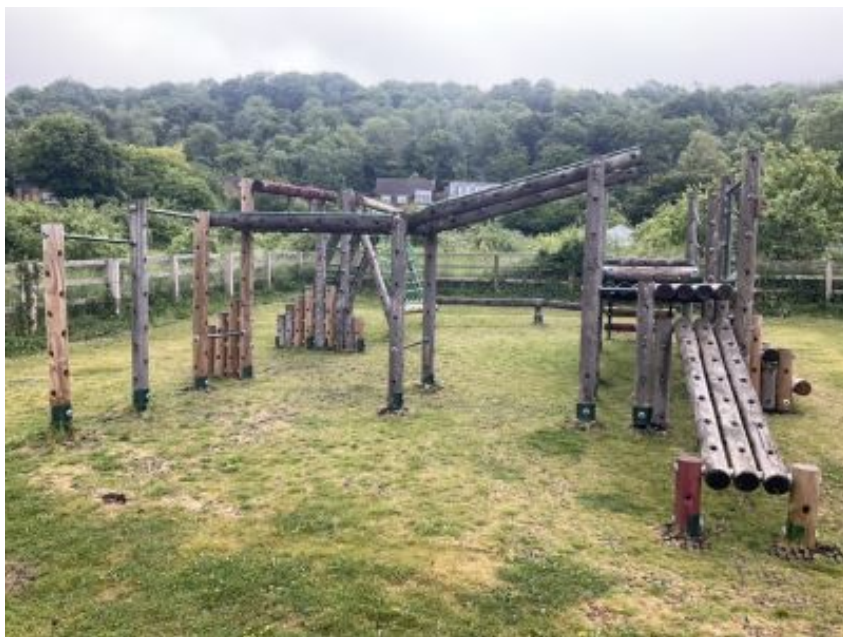
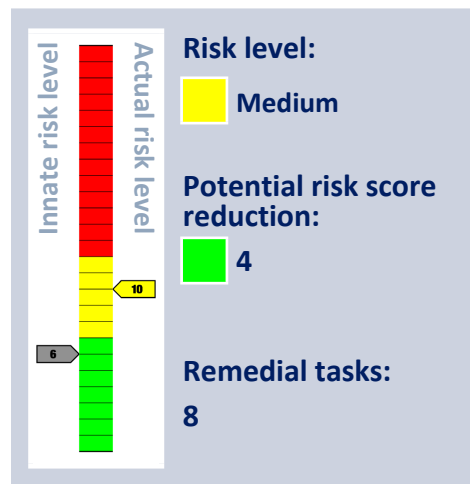
Multiplay - Log World - Activity Centre

1. Timber is not in good condition.
2. Overhead ladders and rings provide significant play value and benefits to children, and with it the risk of falling. Ensuring the surface remains in good condition will help to keep the correct balance between benefits and risk.
3. Fixtures loose or missing.
4. There are splinters or the potential for splinters.
5. Surface needs repair.

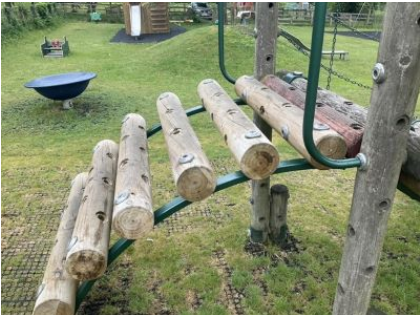
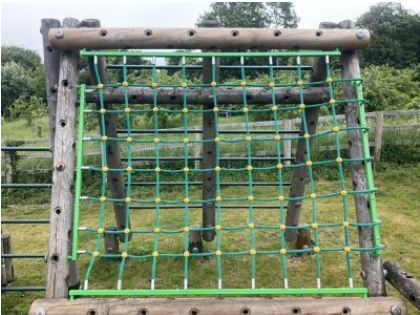
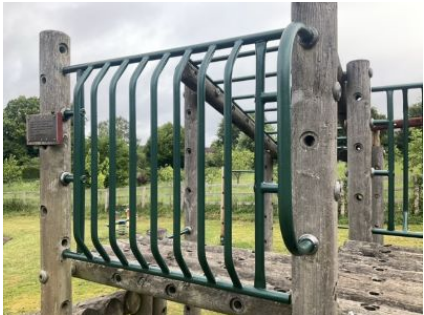
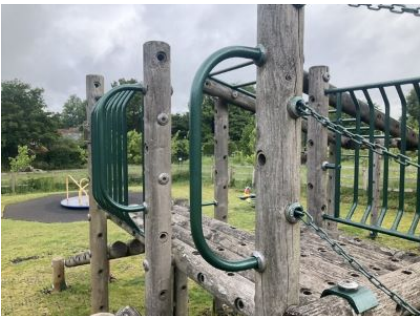
Timber is not in good condition.

Several logs on bridge and at ground level are not in good condition. Consider replacing all affected parts.

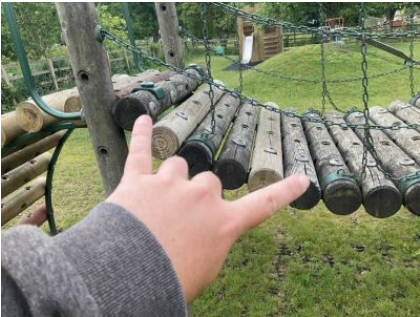
Overhead ladders and rings provide significant play value and benefits to children, and with it the risk of falling. Ensuring the surface remains in good condition will help to keep the correct balance between benefits and risk.

The protective surface under all bars and rings must be kept in good condition.

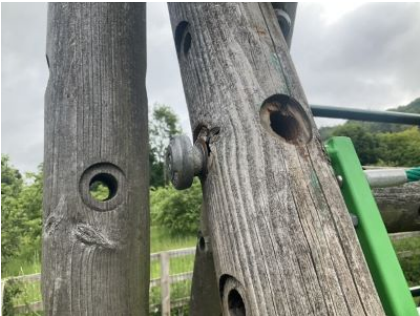
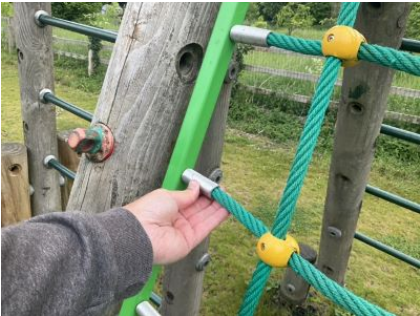
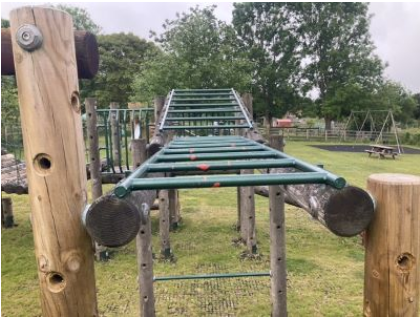
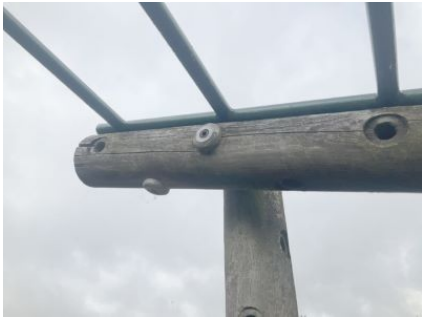
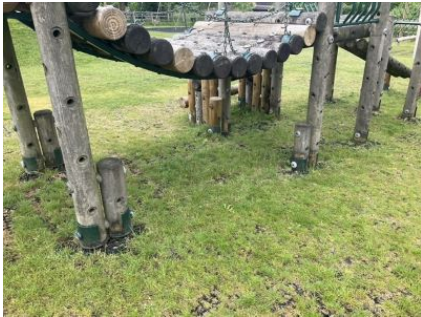
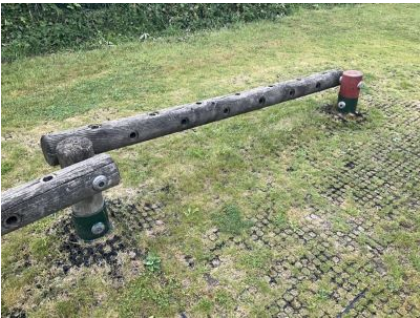
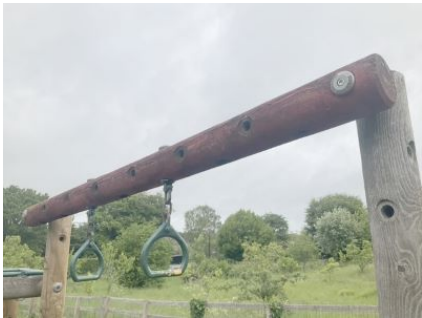
Fixtures loose or missing.

Several connectors on up and over. Log climbers. Post shoe bolts to supports. Overhead ladders and rung top bars/frames. Tighten all loose fixings.

Tighten/replace.

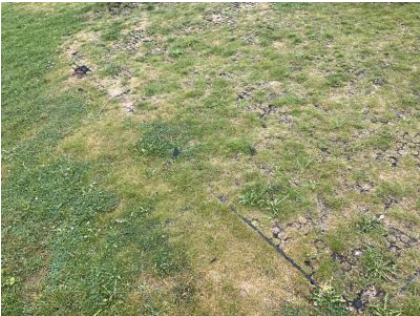
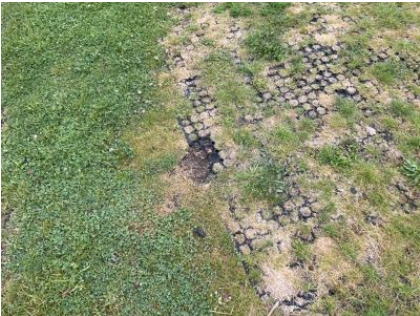
Surface needs repair.

Edges of matting have not been covered over, creating trip points around perimeters.
Damaged areas. Repair/replace.

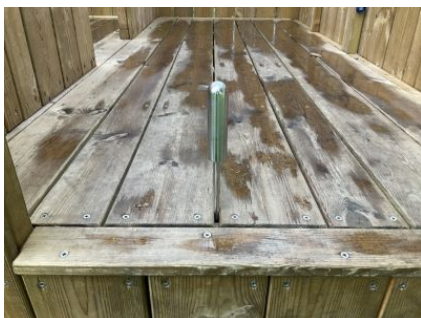
Access fails the entrapment requirements.

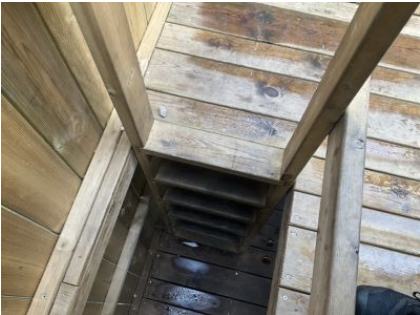
There is wear on the platform.

Repair.

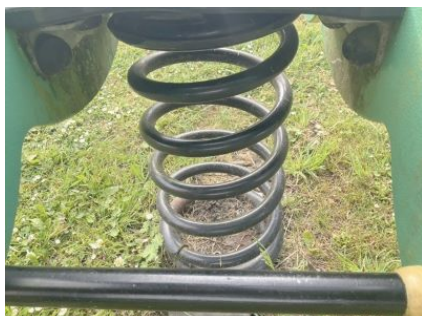
The spring is rusty. These have been known to fail without warning, leading to a collapse of the unit.

Spring cover and early signs of spring. Descale and repaint.
